8 February 2024
Job No: 1092596.0000

Southland District Council
15 Forth Street
Invercargill 9810

Bluecliffs Beach Road Papatotara, Southland Preliminary Hazard and Geotechnical Assessment - October 2023

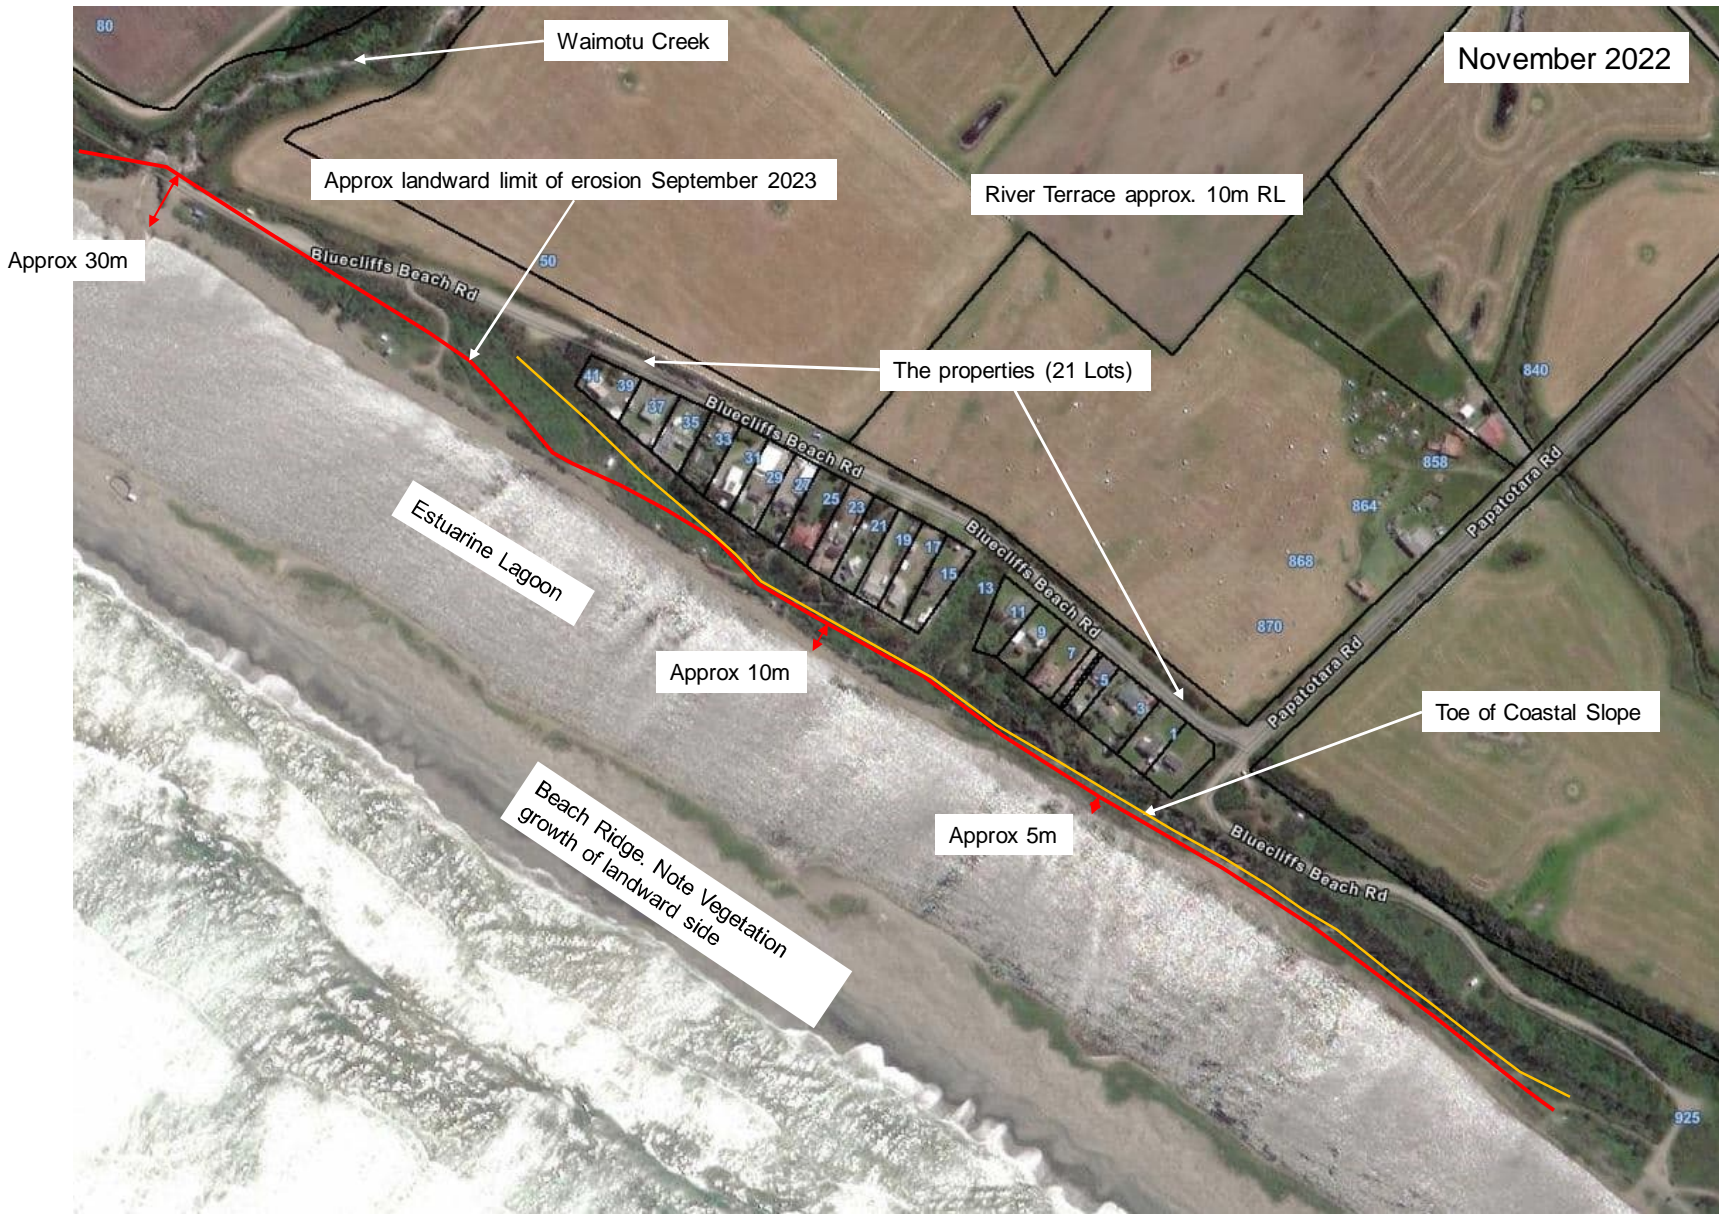
- River mouth 'breakout' from the September storm event occurred as far west as Waimotu Creek, leading to erosion of cliffs, exposure of old retaining wall poles and rock armour at the creek mouth, and erosion of about 50m of the road that gave access to the creek mouth. Approximately 20m of shore erosion plus 5 to 10m of coastal slope and road fill erosion occurred in this area (see Figures 1, 3 and 4, Appendix A).

- The eastern end of the coastal slope exhibits historical erosion exposing bedrock and gravel from the 10m RL river terrace (Figure 1 and 5, Appendix A). Vegetation in front of the slope indicates no, or insignificant erosion along the toe in this area (Figure 3, 5 and 6, Appendix A).

- The position of property boundaries and/or position of the dwellings relative to the crest of the coastal slope varies (Figure 1, 3 and 6, Appendix A). In the east the seaward boundaries are set back some 20m from the crest of the coastal slope, while in the central to west end the boundaries are close to the crest of the coastal slope. Dwellings are set back varying distances from the seaward boundary, with the examples on Figure 6 (7, 23, 41 Bluecliffs Beach Road) being close to the seaward boundary.

See Figure 6 for Cross sections at 7, 23 and 41 Bluecliffs Beach Rd

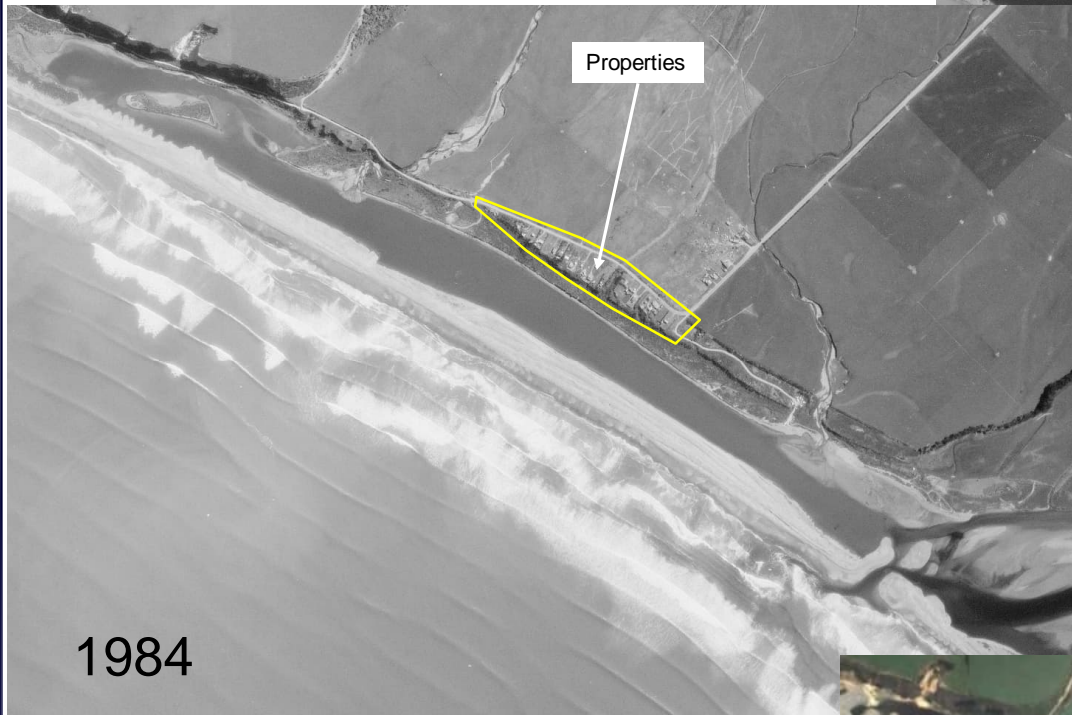
1984

- **1963** infilled lagoon, beach ridges, alluvial fans and remnant ponds. Similar to 1946 and 1955.
- **1984** long lagoon, west end mouth closed, alluvial fans rebuilding, approx. 40m wide shore in front of properties.
- **2013** remnant ponds from long lagoon that was present in 2003, mouth has been in front of properties, likely erosion has occurred at east end of properties.

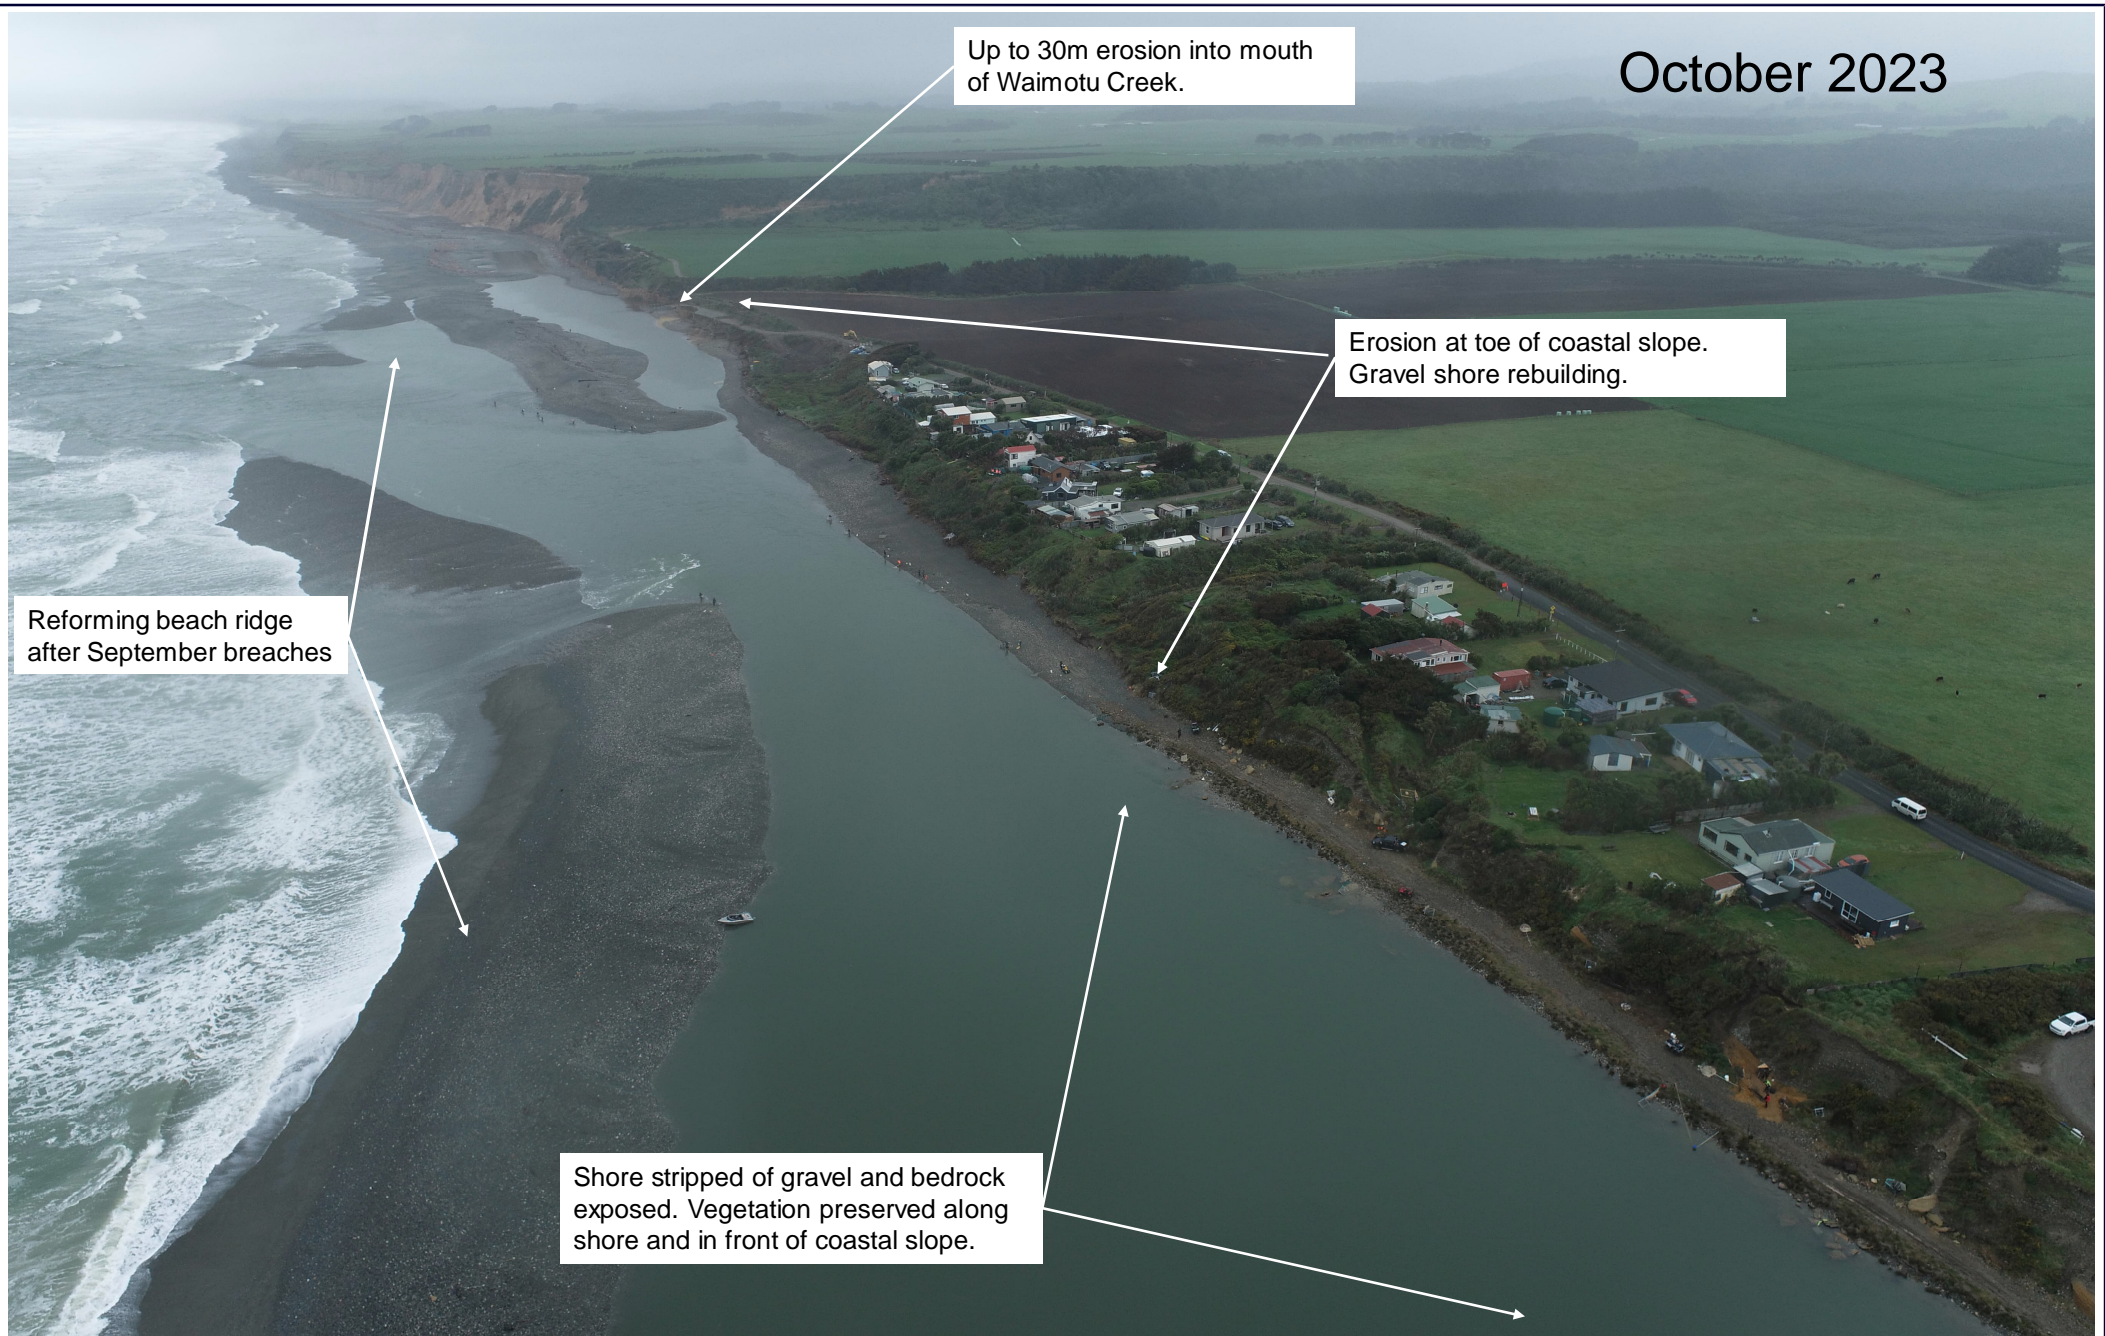
Reforming beach ridge after September breaches

Shore stripped of gravel and bedrock exposed. Vegetation preserved along shore and in front of coastal slope.

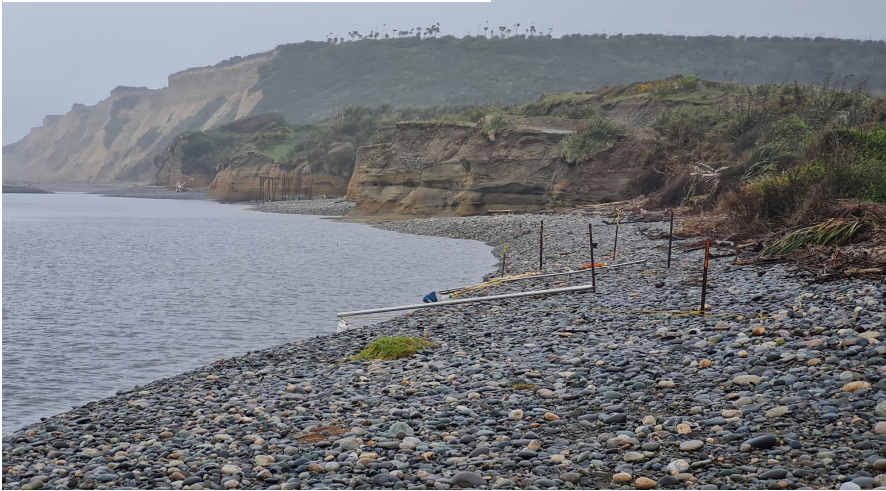
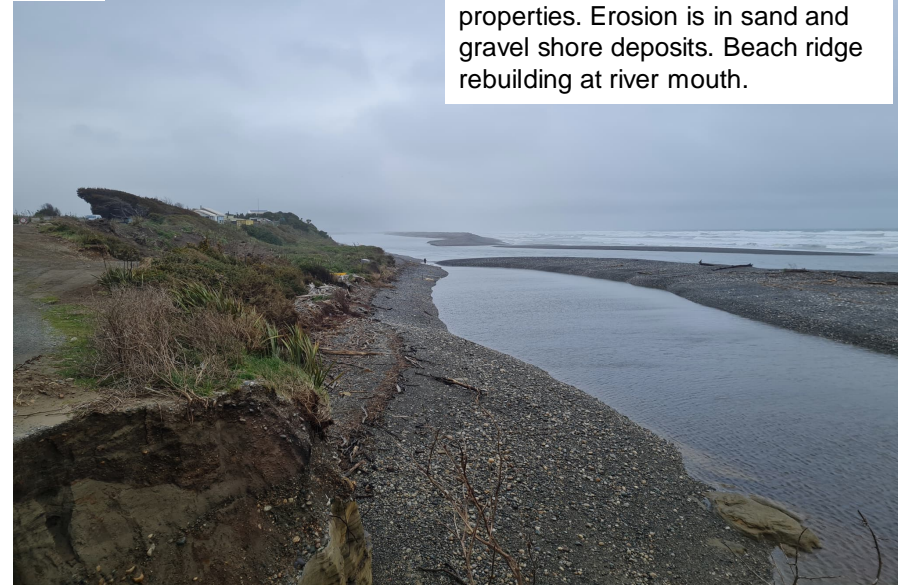
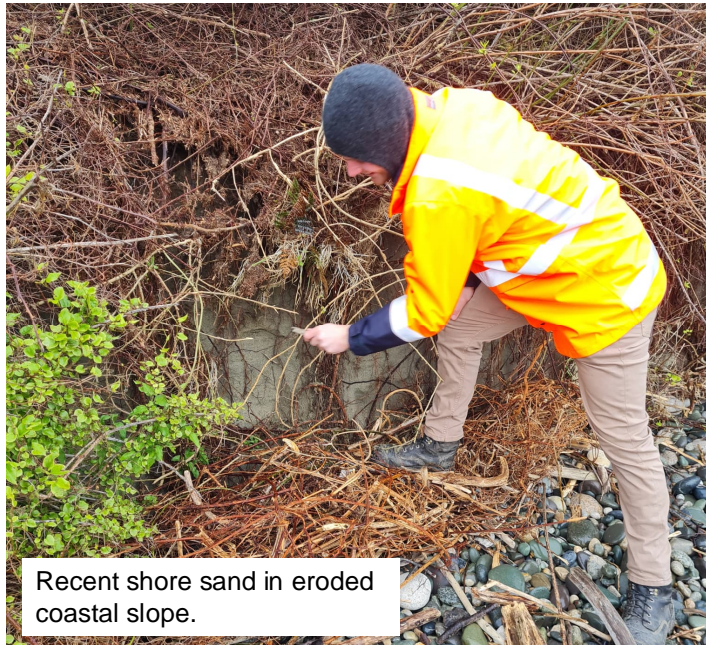
View east from eroded end of road toward the western end of properties. Erosion is in sand and gravel shore deposits. Beach ridge rebuilding at river mouth.

Recent shore sand in eroded coastal slope.

View east from approx. 23 Bluecliffs Beach road. Coastal slope erosion into sand at toe. Gravel beach/shore is rebuilding in front of erosion.

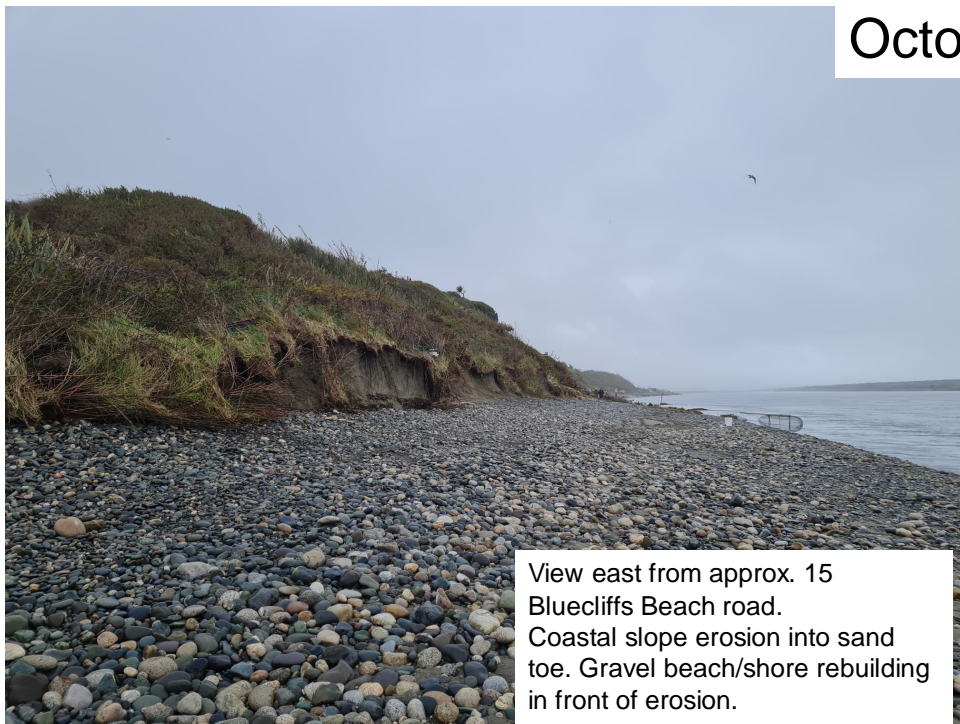
View east from approx. 15 Bluecliffs Beach road. Coastal slope erosion into sand toe. Gravel beach/shore rebuilding in front of erosion.

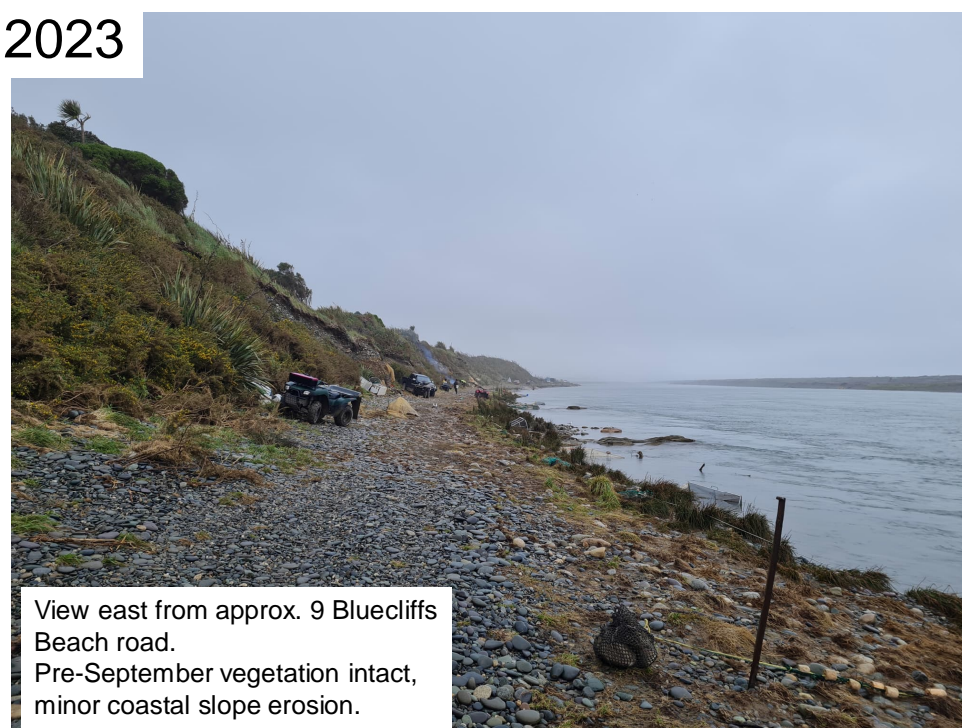
View east from approx. 9 Bluecliffs Beach road. Pre-September vegetation intact, minor coastal slope erosion.

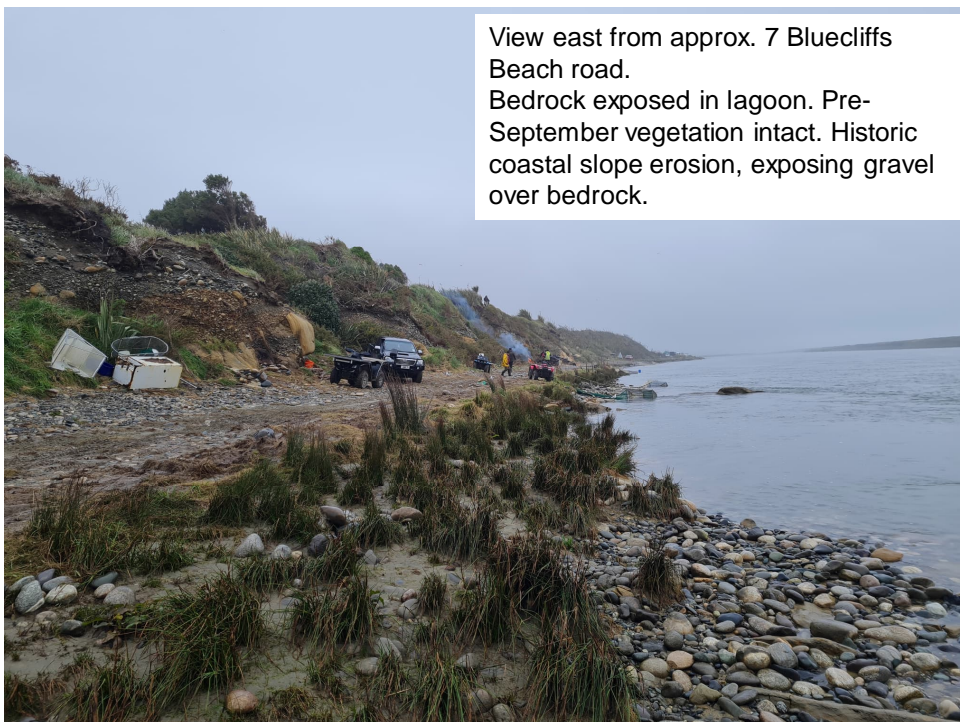
View east from approx. 7 Bluecliffs Beach road. Bedrock exposed in lagoon. Pre-September vegetation intact. Historic coastal slope erosion, exposing gravel over bedrock.

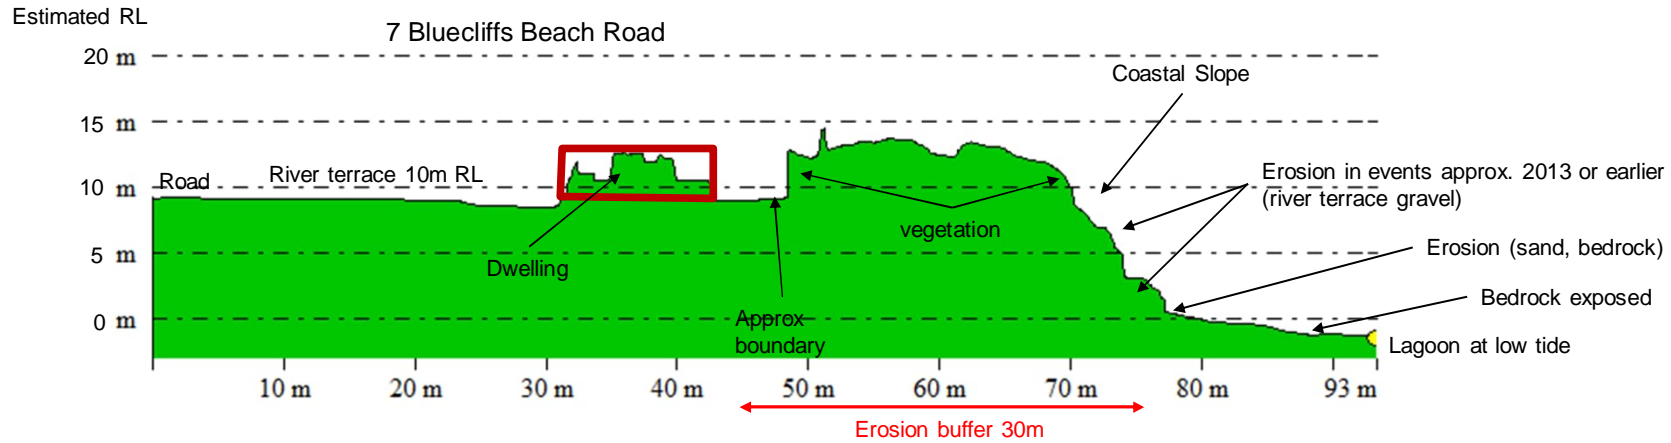
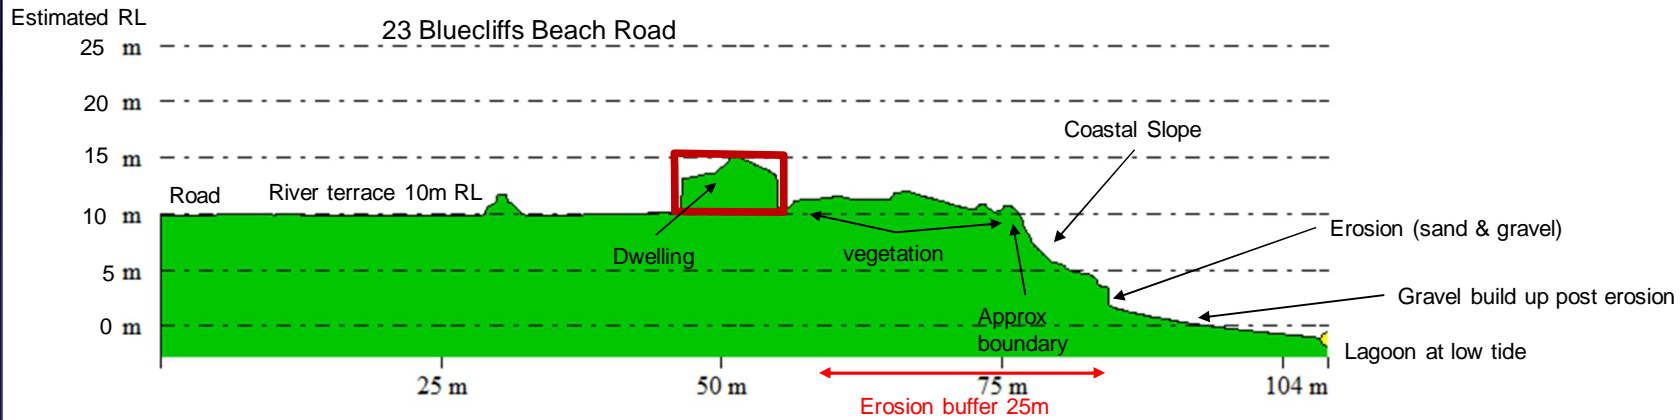
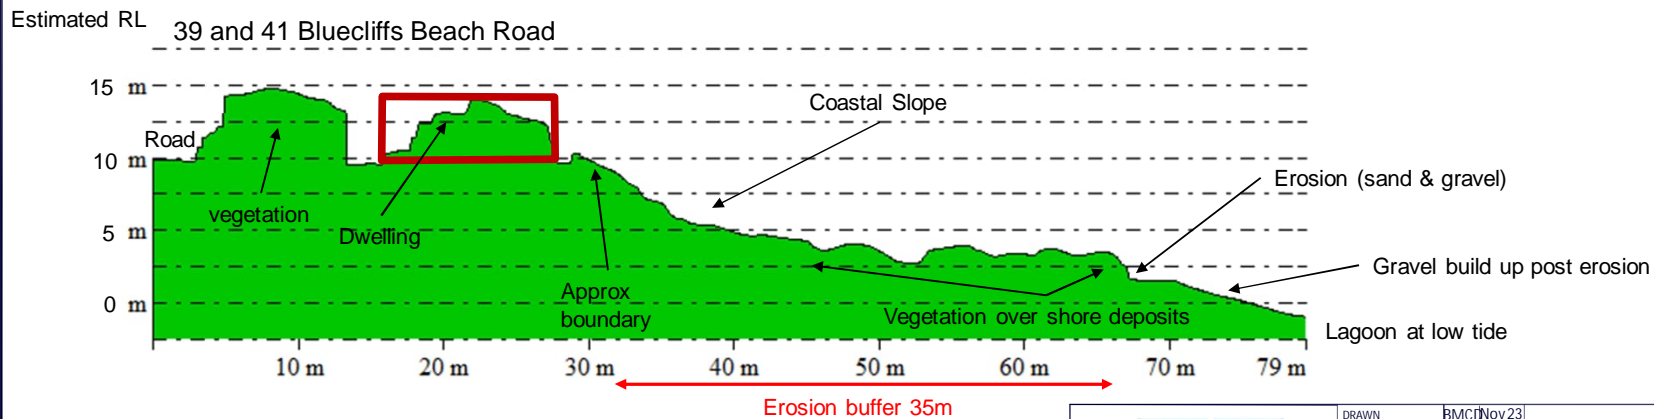
FIG. No. Figure 6

- The distance between the dwellings and current erosion limit varies from about 25m to 35m (Figure 6, Appendix A).

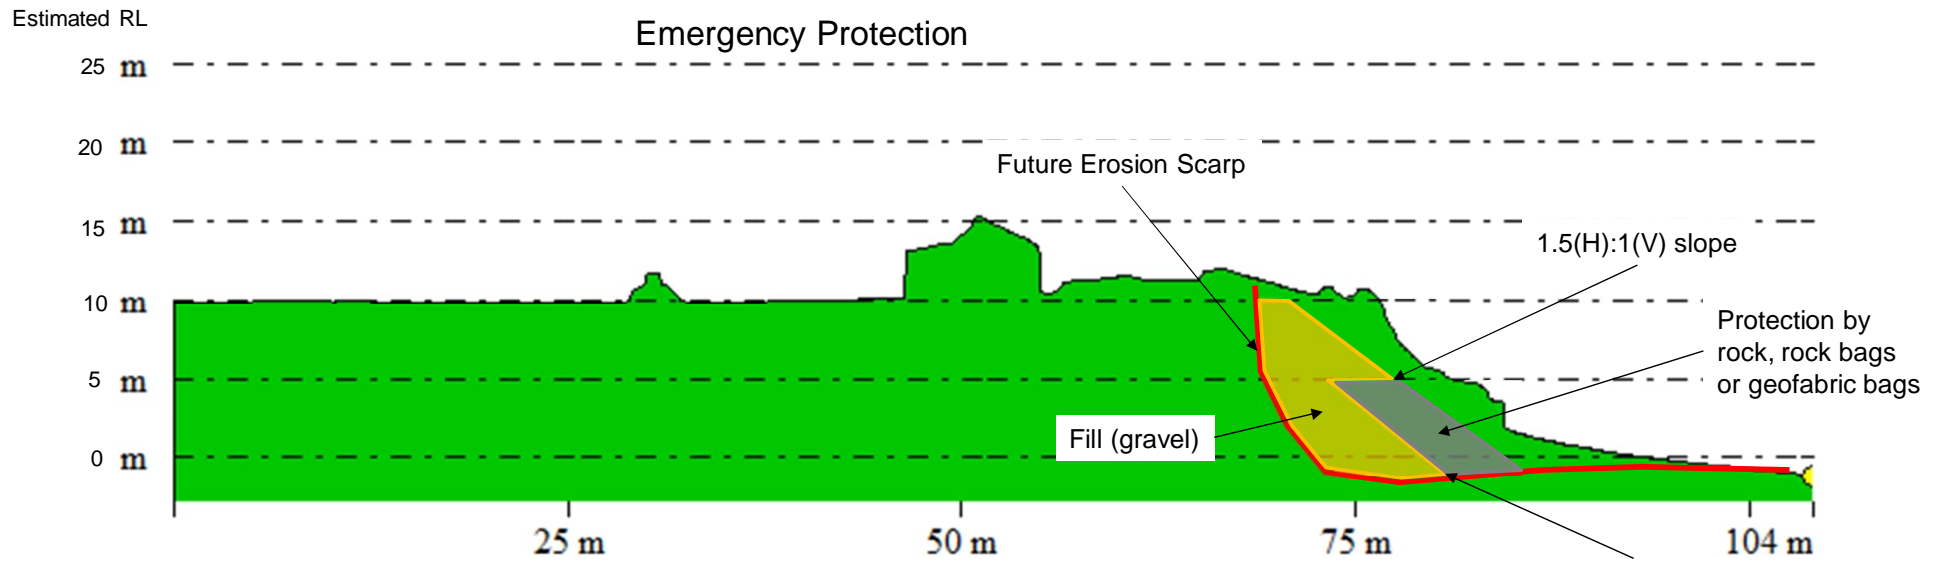
As sketched the toe of protection extends seaward of the property boundary. Permission/consent would be required

Moving back towards the road (Figure 7, Appendix A), either moving the existing house, or demolishing and using a relocatable or mobile dwelling may allow for several decades of future occupation of the properties.

A typical arrangement is shown on Figure 7 (Appendix A), with examples of alternatives to armour rock illustrated on Figures 11 and 12 (Appendix A).

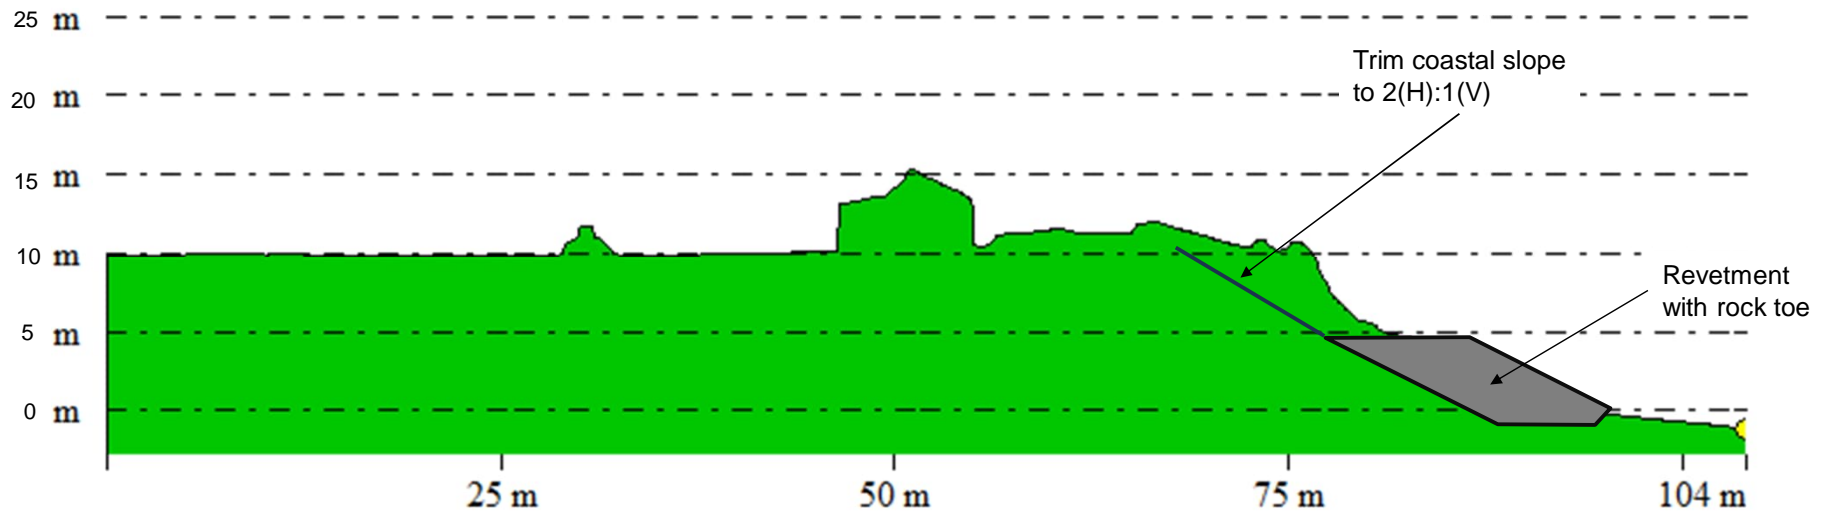
Revetments are shown built into the current position of coastal slope.
Design, permissions and consents required.

The positioning of a revetment onto the existing slope is shown on Figure 9 (Appendix A), with typical section details of a fully designed revetment is presented on Figure 10 (Appendix A).

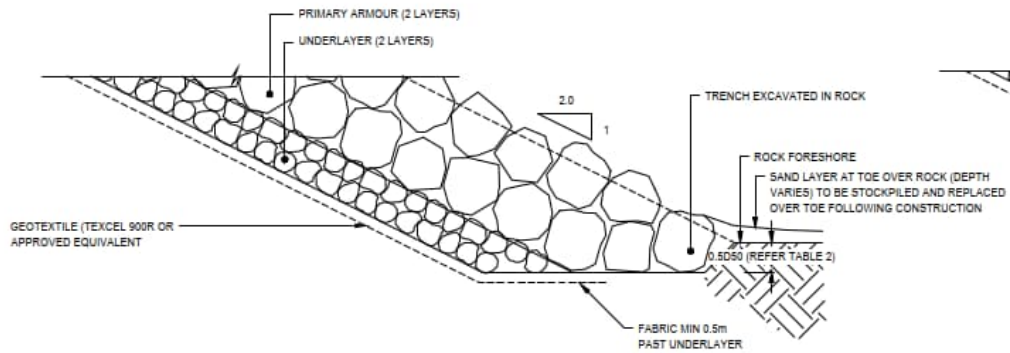
DETAIL A TYPE A EXCAVATED ROCK TOE
SCALE 1: 100 S99-40

Rock toe applies at eastern and possibly western end of properties

Typical arrangement
2(H):1(V) slope
2 layers of rock
2 layers of bedding
Geofabric at base

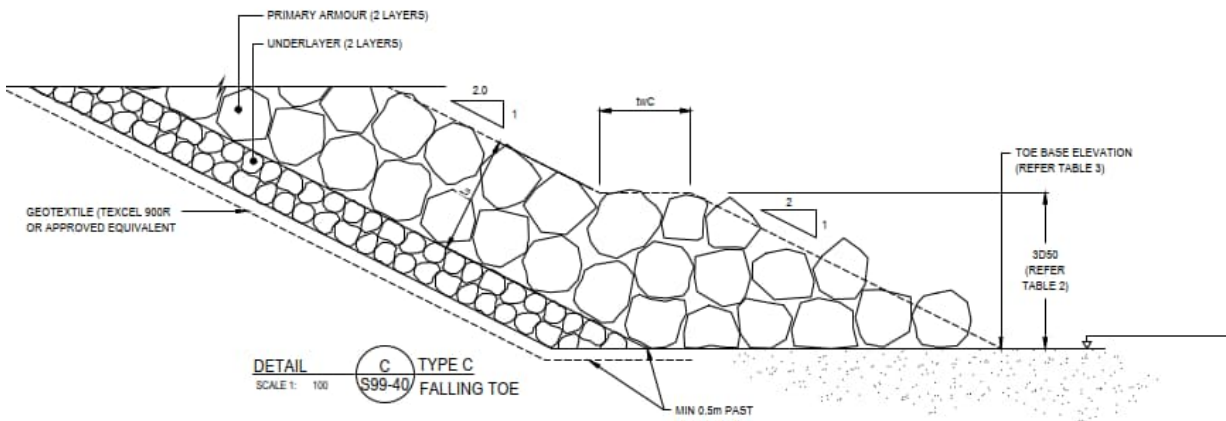
DETAIL C TYPE C FALLING TOE
SCALE 1: 100 S99-40

Falling toe applies in central section where rock is not seen
