memorandum

TO Simon Mapp FROM Ramon Strong
Emergency Management Southland DATE 25 March 2024
RE Waiau River Mouth Opening

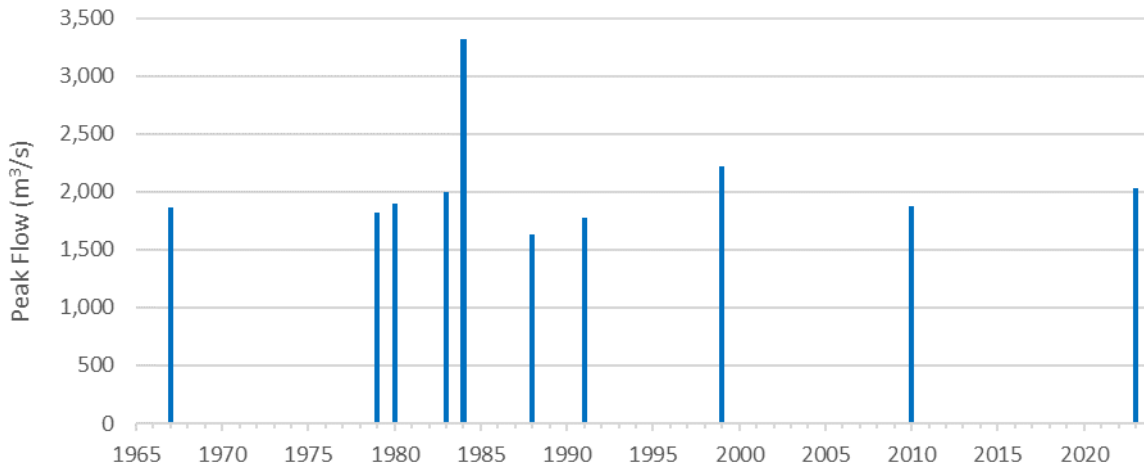
Figure 2: Ten largest events on record (Waiau at Tuatapere).

Figure 2 shows the ten largest flow events in the Waiau at the Tuatapere flow site (NIWA, 2024). It is noted that of these ten floods, four happened in the 5-years between 1979 and 1984. The September 2023 event is thought to have led to increased erosion along Bluecliffs Beach Road. This was the third largest event (peak flow) on record.
