8 February 2024
Job No: 1092596.0000

Southland District Council
15 Forth Street
Invercargill 9810

Bluecliffs Beach Road Papatotara, Southland Preliminary Hazard and Geotechnical Assessment - October 2023

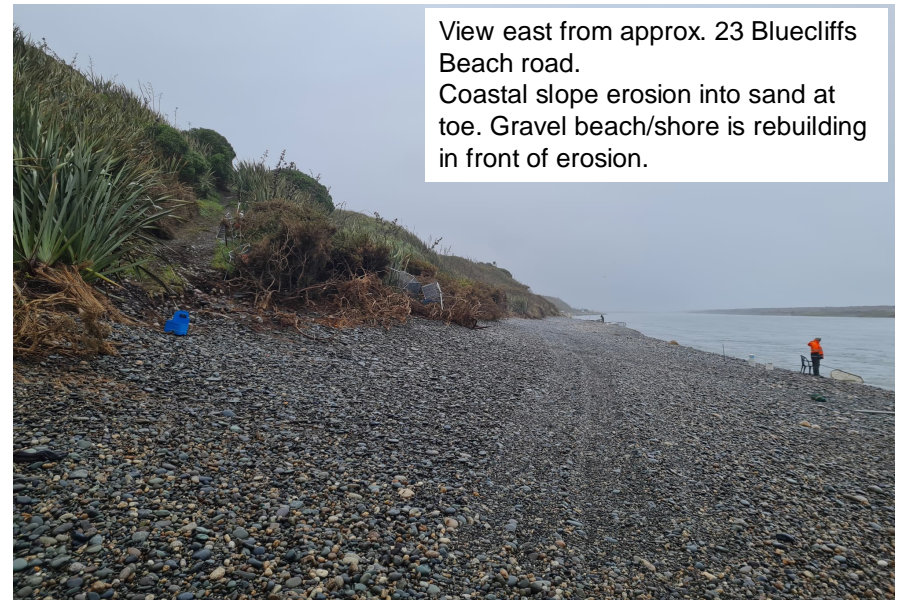
Recent shore sand in eroded coastal slope.

View east from approx. 23 Bluecliffs Beach road. Coastal slope erosion into sand at toe. Gravel beach/shore is rebuilding in front of erosion.

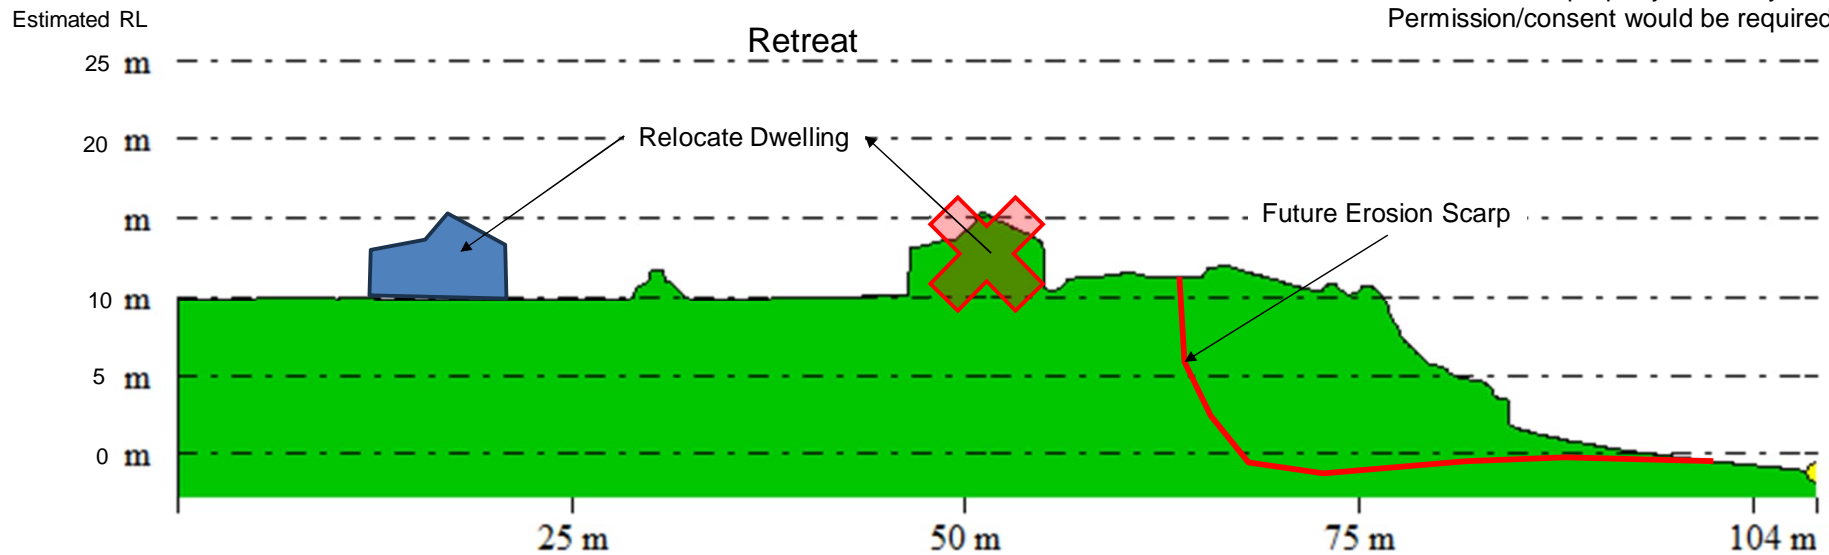
As sketched the toe of protection extends seaward of the property boundary. Permission/consent would be required

Moving back towards the road (Figure 7, Appendix A), either moving the existing house, or demolishing and using a relocatable or mobile dwelling may allow for several decades of future occupation of the properties.

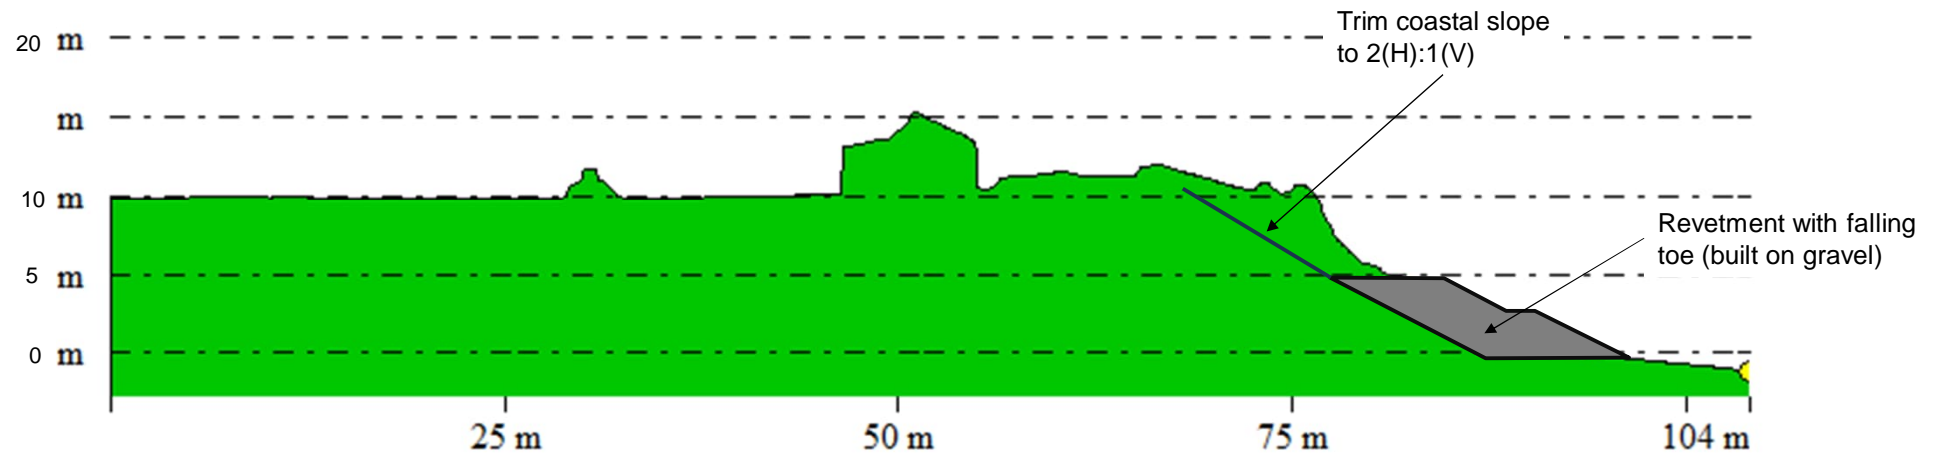
Revetments are shown built into the current position of coastal slope.
Design, permissions and consents required.

The positioning of a revetment onto the existing slope is shown on Figure 9 (Appendix A), with typical section details of a fully designed revetment is presented on Figure 10 (Appendix A).
